ASSEMBLY RELIABILITY OF BGAs AND EFFECTS OF BOARD FINISH

Reza Ghaffarian, Ph.D.
Jet Propulsion Laboratory (JPL)
California Institute of Technology
Tel: (818) 354-2059
email: Reza.Ghaffarian@JPL.NASA.Gov

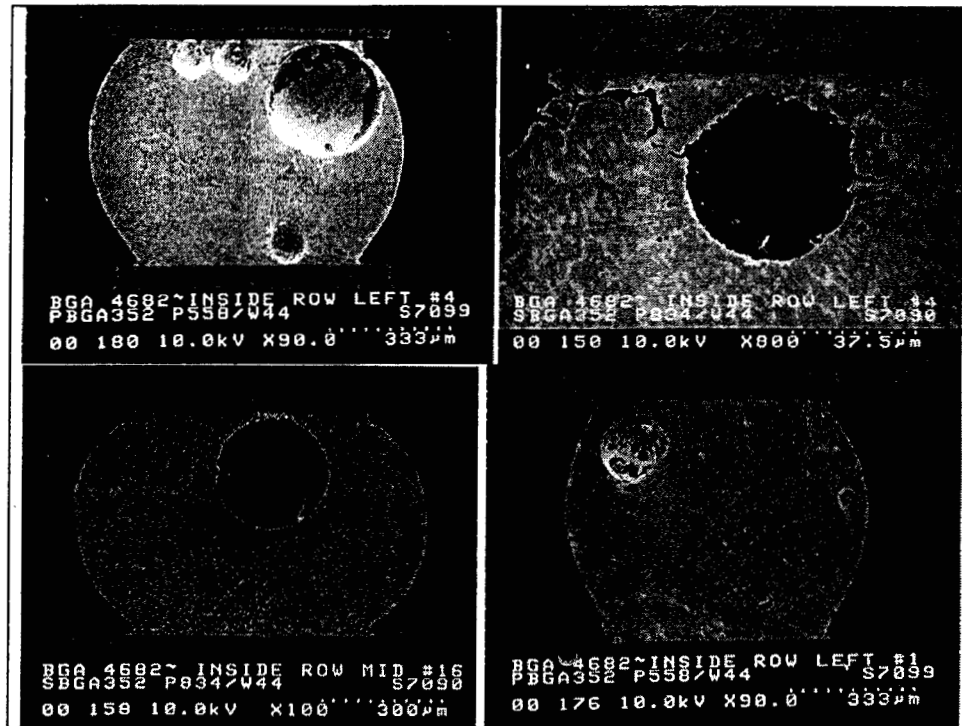
Figure 1 Voids in PBGA. Cross-section photos for PBGA 352 and SBGA 352 of Solder Balls with Void and Cracking after 4,682 cycles (-30°C to 100°C)

Figure 1 includes a collection of SBGA and PBGA solder joints with voids at different locations in the solder joints. Generally, most of voids are close to the package side for PBGA assemblies. The upper right hand photo shows how cracks propagate in and out of a void. A crack initiated at the package corner interface and propagated into a void at a 45 ° angle and leave void parallel to the package interface. The two types of cracks represent a mix mode of stress conditions.

Note also that the large void in the lower left photo shows evidence of mounting materials from metallographic preparation. This is puzzling since there is no evidence of a through-crack. Perhaps a

crack, normal to the photograph's cross section, has interconnected the void to the outer balls' surface. This reveals the complexity of failure modes and remind us of the caution that must be exercised when interpreting failures by two dimensional cross-sectioning. Ideally, a three dimensional characterization is needed to better interpret the results.

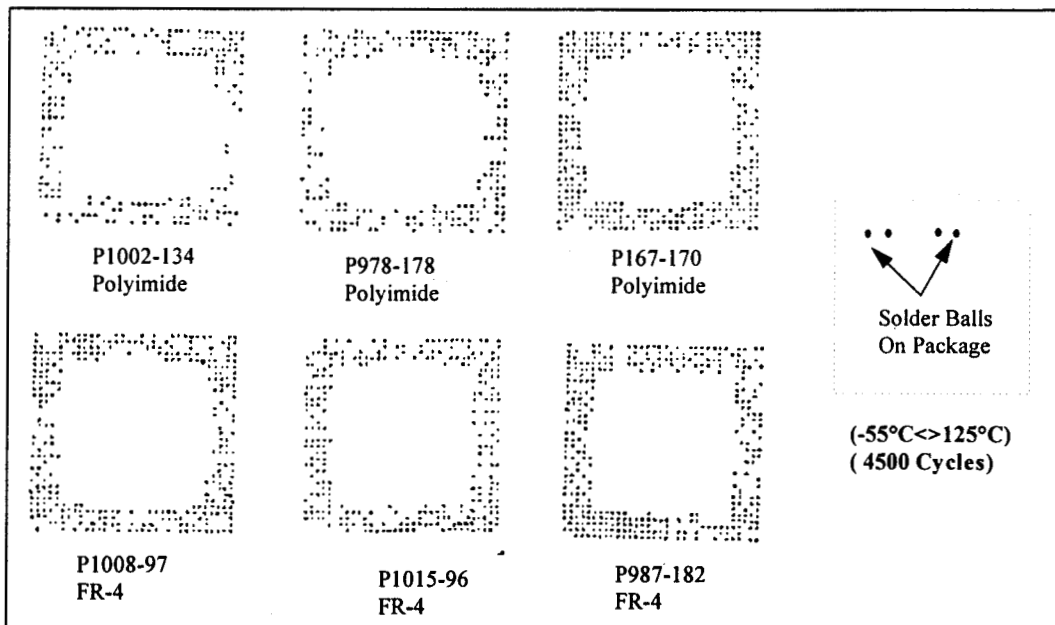
Figure 2 Map of board/package failure sites for SBGA 560 after 4,500 B cycles. Packages were detached and solder balls on the package were then mapped

Package attachments were very weak after 4,500 B cycles and were easily detached from the board. Cycled packages were detached and balls were inked and their images were mapped. The ball map distributions for several detached SBGA560 are shown in Figure 2. All joint failures were not from the board interface. There appeared to some trend in their distribution.

Most balls were separated from the board interface for SBGA 560 on FR-4 boards as evidenced from the large number of dark spots which represent the balls on the package. This is not true for those on polyimide boards. There were more joint separations at the package side for polyimide boards, which might be due to the higher thermal stability of polyimide compared to FR-4 in the B thermal cycle.

Note also there was separation of one whole edge row from the package side. This might represents the existence of high warpage for the outer-package edge generally observed for the plastic packages. Similarly, mappings for other plastic packages were carried out and trends were studied.

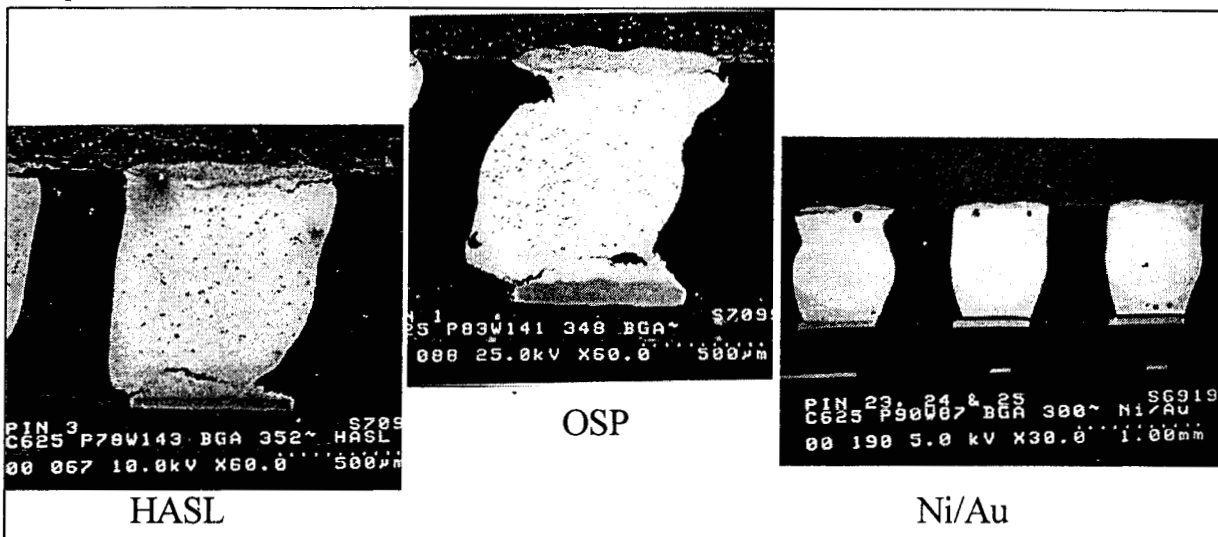
Figure 3 Failure Mechanisms for Joints on OSP, HASL, and Ni/Au Surface Finishes for CBGA 625 under A Conditions (-30°C to 100°C)

Ceramic package failure under A cycling conditions for PWBs with different surface finishes are shown in Figure 3. Both HASL and OSP failures, initiated at the PWB side, showed ductile features evidenced from the zigzag propagation through the eutectic solder joint. This generally was not the case for Ni/Au. For Ni/Au, several joints of a package showed brittle failure, which was first noticed during a routine visual inspection of the assemblies.

Brittle failure by the gold embrittlement could be one possible explanation, if the amount of gold exceeded three volume percentages of the solder joint. This was not the case, since the thickness of gold was controlled by an immersion technique to 3-5 µinch. To assure this was the case, a sample joint of Ni/Au surface finish was analyzed for various trace elements at PWB interfaces using the Energy Spectroscopy for Chemical Analysis (ESCA) feature of SEM.

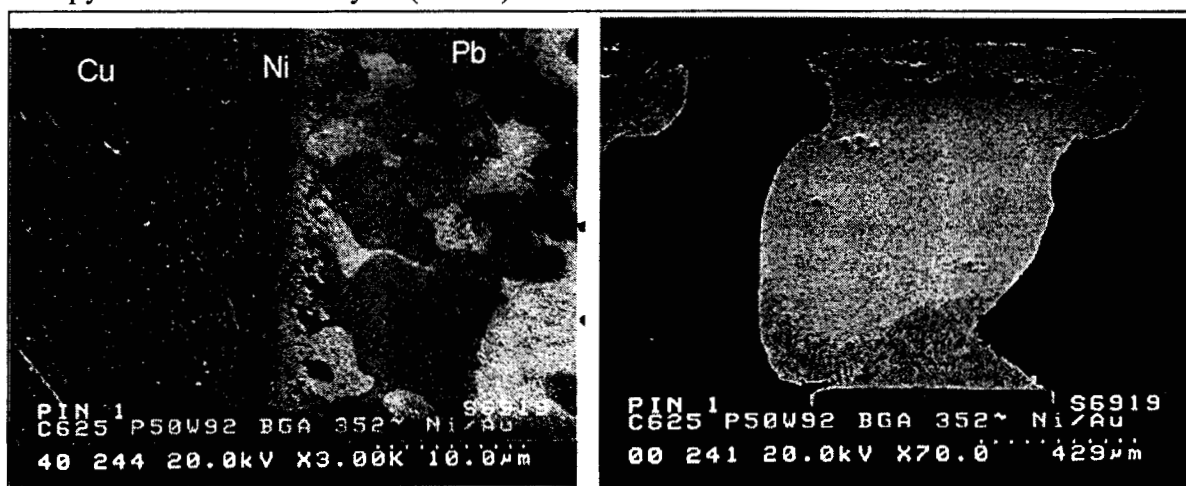
Figure 4 Magnified Photos of Ni/Au Interface Surface Finish

A cross-section photo with elements in each phase is shown in Figure 4. Qualitative elements detected by probing at various sections of the joint are also determined. No traces of gold were detected,

possibly because the low amount of gold could have been dissolved during the reflow process. Other elements were as expected and included Cu, Ni, P, Pb, and Sn. Existence of phosphorus traces indicates the chemistry of the bath used for Ni plating. This element is found in a common chemistry used for the Ni surface finish.

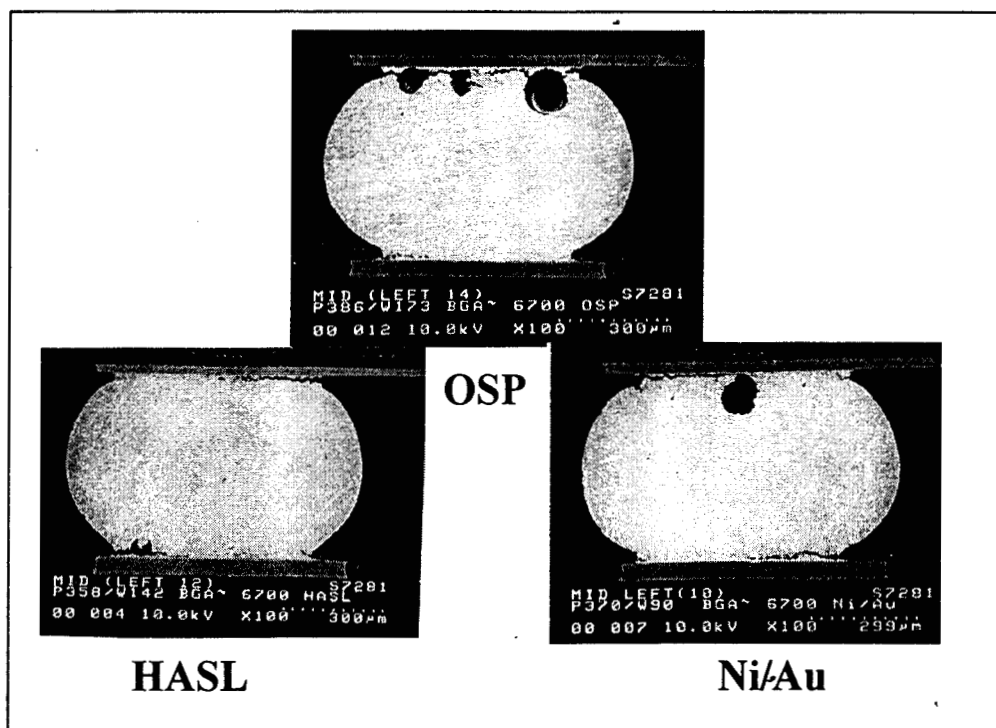
Figure 5 Surface finish and failure for PBGA 256 after 6,700 A cycles

Figure 5, shows cross-sectional micrographs of the PBGA 256 after 6,800 A cycles. Photos are for three types of surface finishes, OSP, Ni/Au, and HASL. The failures are very similar to those seen previously for assemblies after 4,800 cycles with the OSP finish. There is no apparent difference of failure mechanisms among the three surface finishes. Ductile failure is the principal failure mechanism for the three surface finishes. Similarly to other plastic packages, failures were either at package or board side. Generally, voids were accumulated at the package interface.

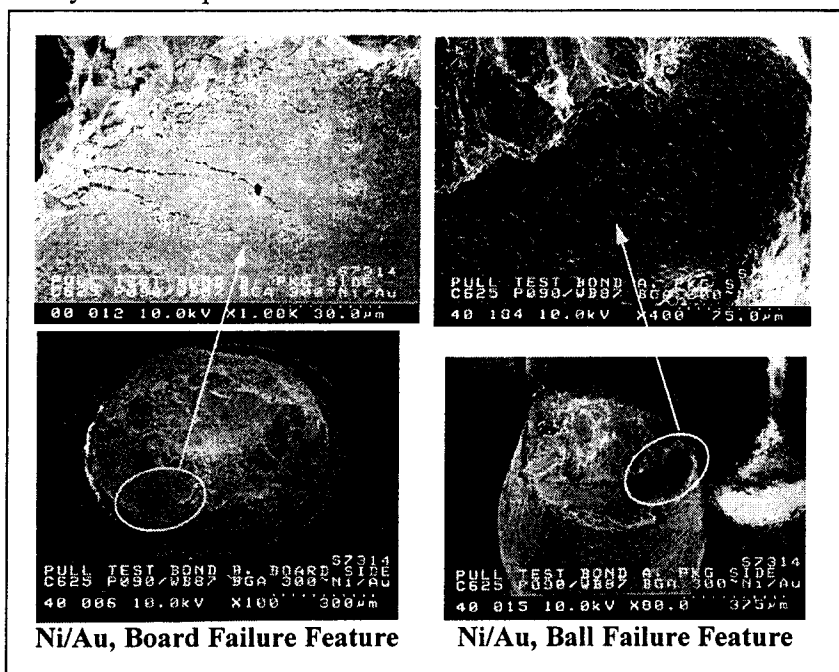
Figure 6 SEM photomicrograph of detached ceramic package on Ni/Au surface finish with brittle areas

Out of 525 separated balls, only 13 balls remained on the board and the majority ($525-13= 512$) were still attached to the package. Out of 512 pad separations on the board, 470 were pulled from traces and 42 were by solder joint separation. Out of these 42, only 3 pads showed partial signs of brittle failure. The crescent surfaces were from 1/3 to about 1/4 of the pad area.

Figure 6 shows the SEM photomicrographs for brittle failure features on ball and package pads. Figure 7 shows elemental analysis of the ball and pad surfaces by ESCA. For ductile failure regions, the elements were found to be Pb and Sn of eutectic solder composition, as expected. This was not the case for brittle surfaces. At the smooth ball surface, elements included Ni, P, and Sn, whereas at the pad surface, they were mostly Ni. Pimples on the ball surface were Sn.

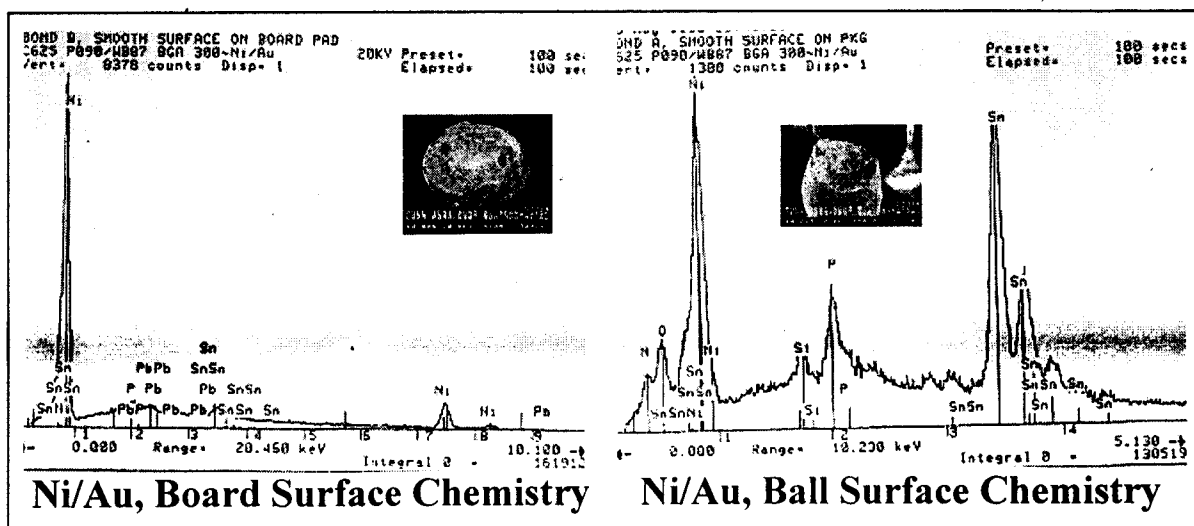
Figure 7 Elemental chemistry of brittle surface shown in Figure 6

- Elemental analysis of one brittle Ni/Au surface finish revealed no detectable gold, but a reasonable amount of phosphorous and Ni on the detached solder ball surface. Phosphorous segregation at the interface, surface contamination during Ni/Au plating or after plating by diffusion, and brittle fracture of Ni-P and Ni_3Sn_4 were shown to be the three potential failure mechanisms^[1]. This is the case when the Ni/Au content is less than 1% and there is no potential of gold embrittlement.
